Re: August 2015 Monthly Progress Report
Administrative Settlement Agreement and Order on Consent for Removal Action
U.S. EPA Region 10 Docket No. CERCLA 10-2009-0255
Gasco Sediments Site within the Portland Harbor Superfund Site

Visual Observations Log Form

Monitoring Period: Monthly (Year 9) — August 2015

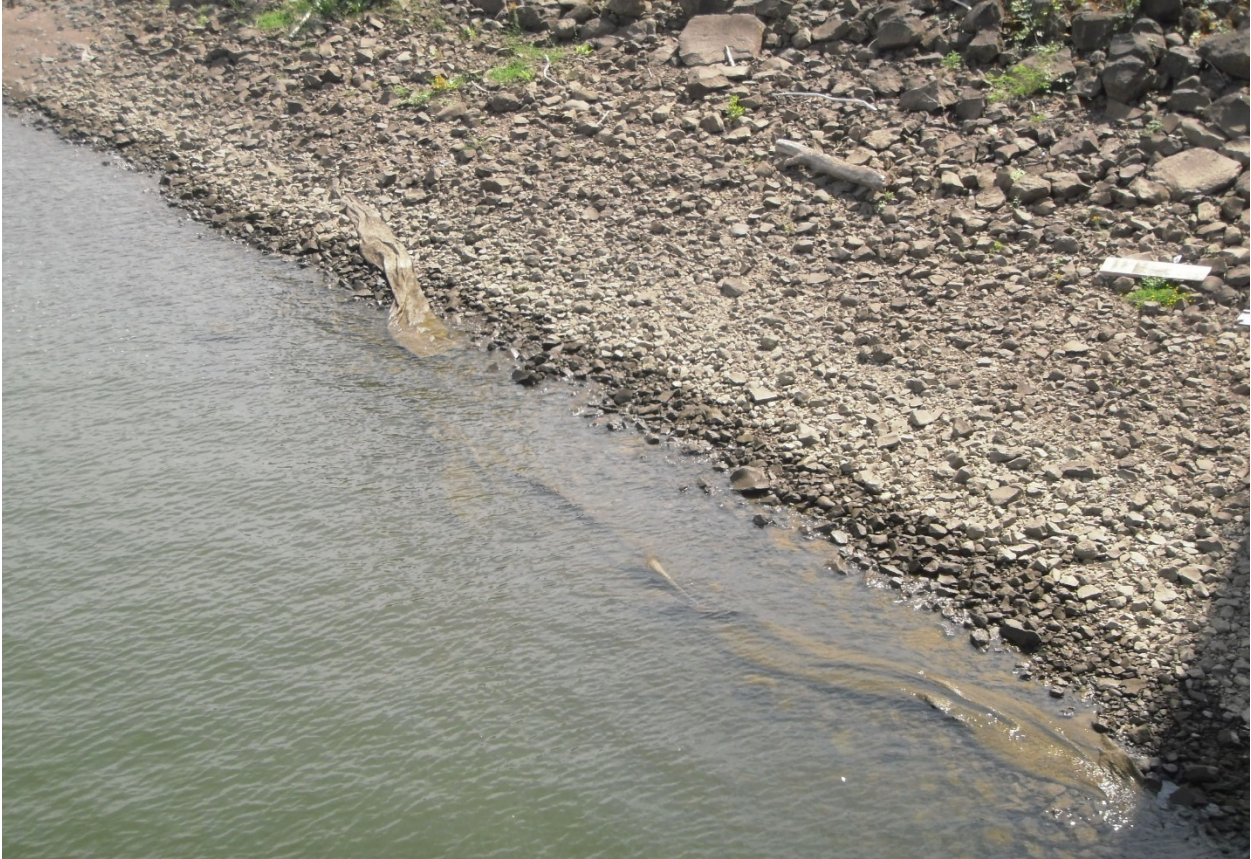
Observations of Erosion/Deposition: No erosion or deposition was observed along the shoreline. All previously noted organo-clay mat material segments are visible and mostly out of water. The 5-foot section near the lateral midpoint of the cap area is 15 feet from the shoreline; approximately 10 feet of the 20-foot section upriver perpendicular to the shoreline dry and above the water's edge; and 10 feet of the 40-foot section at the downriver end is out of water with the remainder submerged near the water's edge (Photo 1).

Photo 1 — *Visible section of organo-clay mat along the shoreline at the downriver extent of the cap area (8/24/15):*

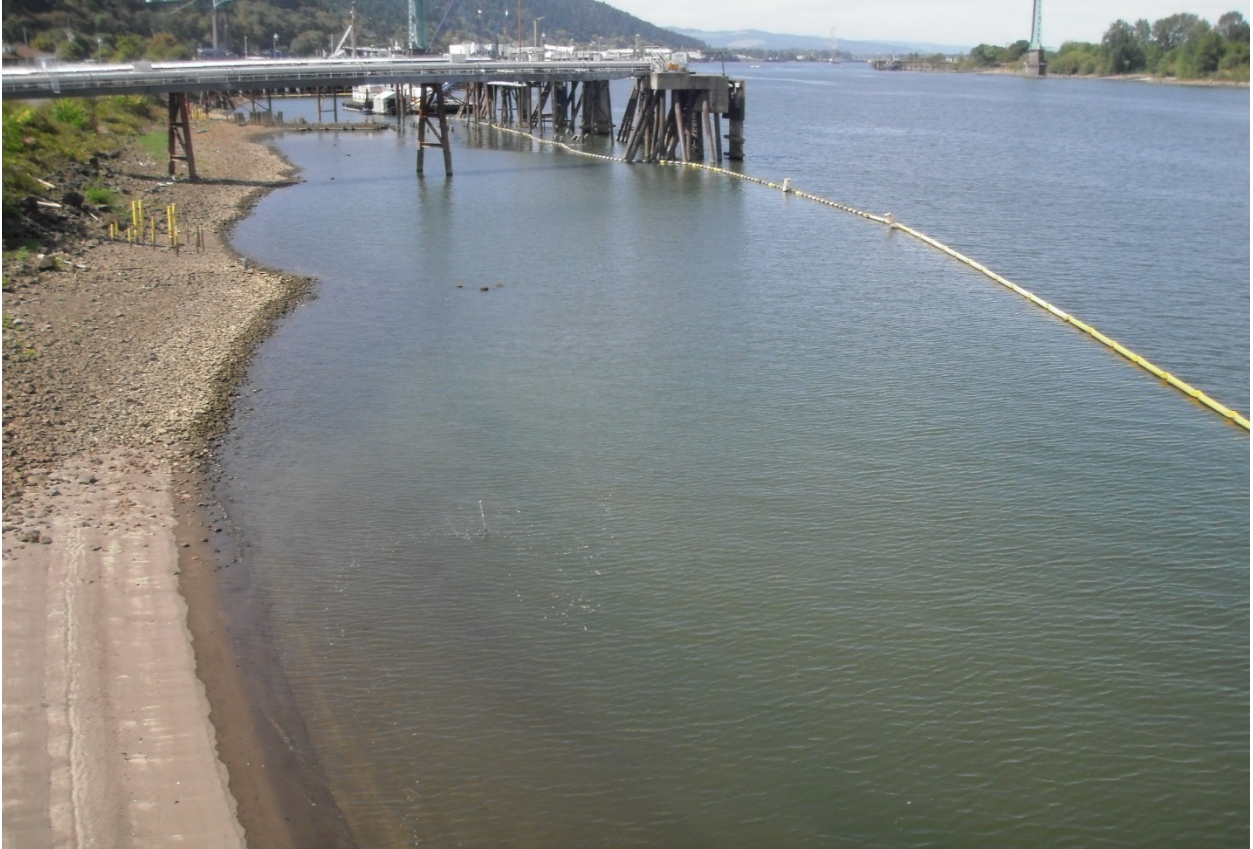
Observations of Long-term Controls (i.e., oil booms, organo-clay mat, etc.) During the observation, the Fuel and Marine Marketing (FAMM) containment boom was in place, across the cap area, between the upriver corner of the ship dock and the wooden dolphin (near the upriver extent of the site and near the Siltronic Corporation outfall). Two buoys that identify the cap area to mariners are in place as installed. The position of the FAMM oil boom, warning buoys, and a general overview of the site shoreline is shown in Photo 2.

Photo 2 — *FAMM oil boom placement and mariner warning buoys at pilot cap area. 8/24/15):*

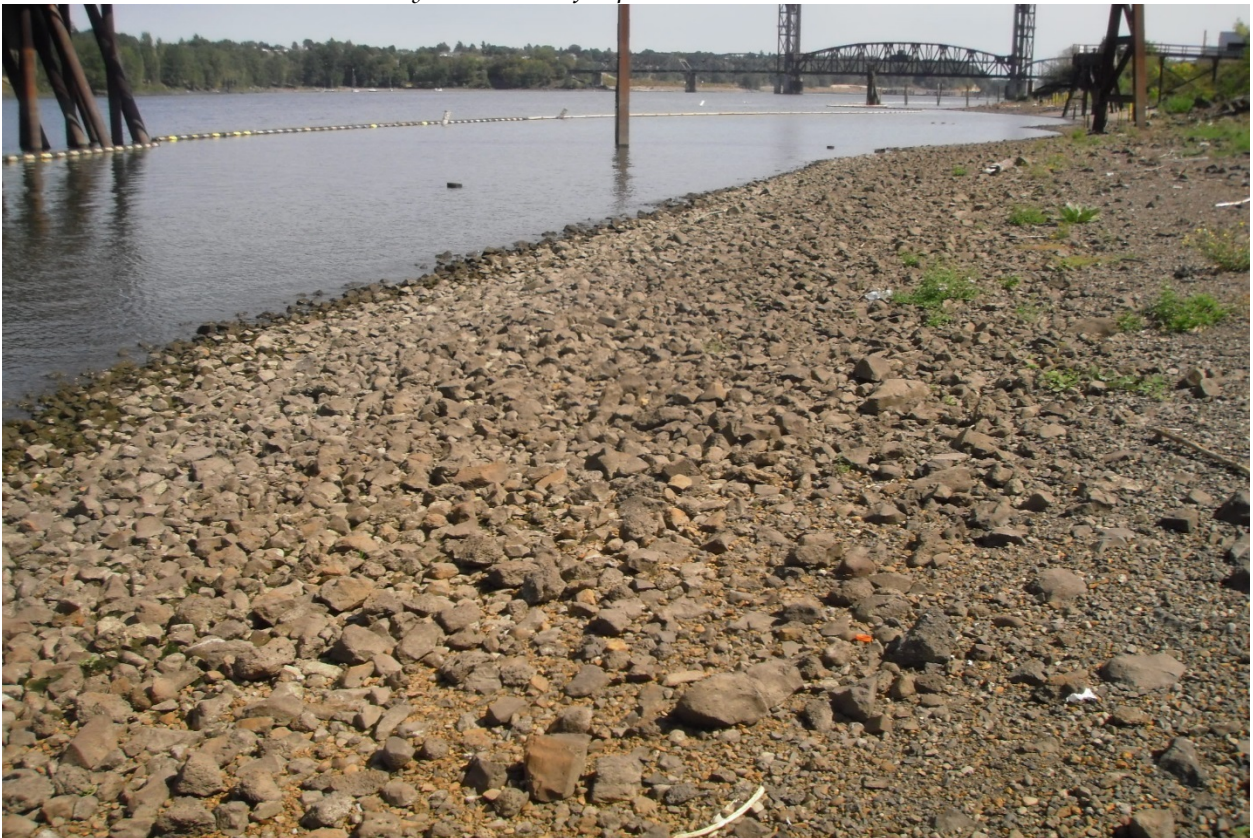
No sheen is evident in or around the cap area. Photo 3 shows the water surface and shoreline immediately downriver of the sediment cap.

Photo 3 — *Conditions immediately downriver of cap area (8/24/15):*
